Monsanto

DATE May 20, 1983
SUBJECT Incident Investigation
Department 233
REFERENCE
TO J. Boehm

Date of Incident: April 29, 1983
Type of Incident: Approximately 12:45 p.m.
Location: Department 233 sewer outflow
Type of Incident: Hot sewers
Most Probable Causes: Inadequate separation in sewer
pit due to mixing of benzene and
MCB.

INCIDENT

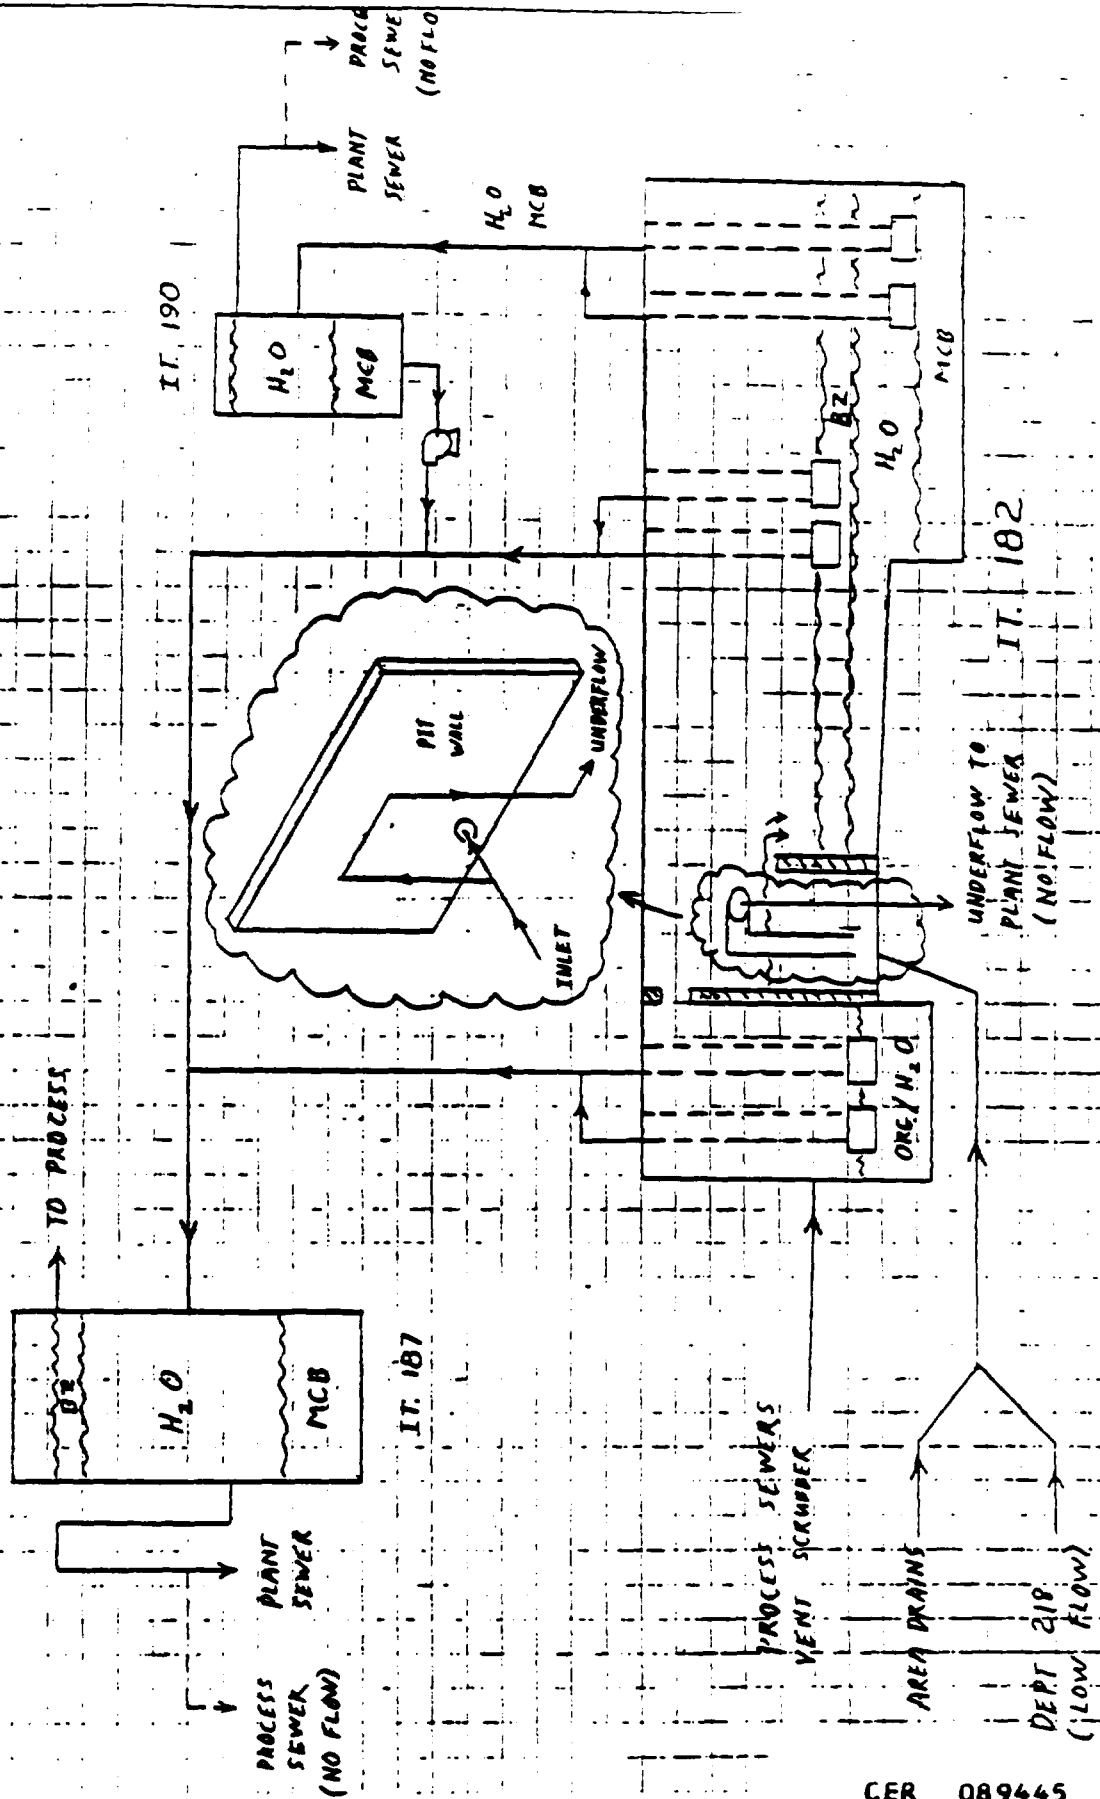
FIG 1 DEPT 2 & 3 SEWER COLLECTION SYSTEM

The purpose of the Collection Pit is to collect, contain, and gravity separate all process fluids draining from the MCB and Muriatic Acid (Department 218) operating facilities. The pit is made up of three compartments (Figure 1). The first compartment collects flows from the process drain system including the benzene contaminated streams coming off the benzene-water separator drain leg and vent scrubber. The organic waste streams entering the first compartment are routinely pumped to the Collection Tank for further separation. This first compartment overflows into the intermediate compartment of the Collection Pit during high flow rates.

The third piece of equipment is the Collection Tank (Item 187) (see Figure 1). The vessel receives waste streams pumped from the first and third compartments of the Collection Pit. This vessel is designed to separate the light and heavy layer organics from the aqueous phase. The light layer organics overflow continuously to the Overflow Receiver for recycling into the process. The heavy layer is retained in the bottom of the tank for further processing. The aqueous layer flows continuously to the plant sewer. This is the third and final point at which wastes enter the plant sewer. A nuclear density meter also monitors this flow. On a high or low density reading the stream is diverted to the process sewer.

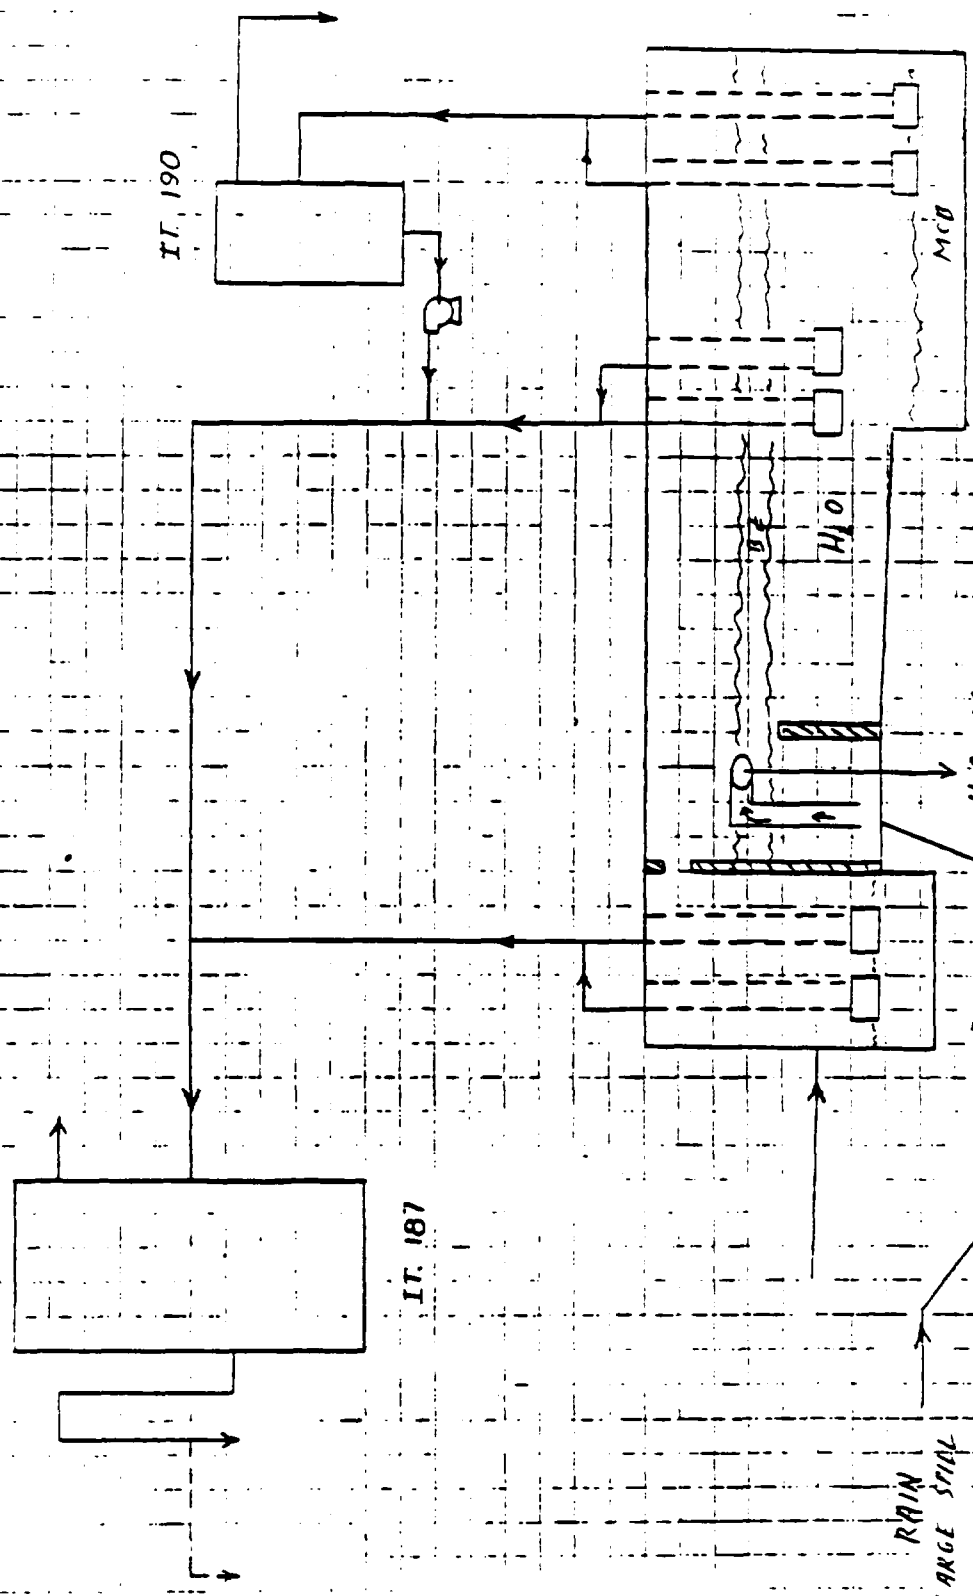
FIG 4 DEPT 133 SEWER COLLECTION SYS

1. Benzene had been present in the sewer system since starting the night before. It was contained in the HCl off gas being scrubbed by the drowning jets. The benzene had been separating from the water layer efficiently all through the night, as no benzene was originally detected in the water underflow.
- 2) MCB entered the sewer system when the high stage cooler and the surge tank were drained that morning. However, this did not present any immediate problem since the benzene and MCB flows remained separated. The benzene flowed into the intermediate compartment, where it separated from the water phase and overflowed into the third compartment. The MCB drained into the first compartment, where it was pumped to the collection tank (see Figure 4).

3. The third condition, mixing, was met when the MCB filled the collection tank and began overflowing through the water outlet to the plant sewer. To prevent the MCB from entering the plant sewer, it was diverted to the process sewer, where it flowed to the first compartment of the collection pit. However, this compartment was already full of MCB. With the addition of the recycle flow, the MCB rich phase overflowed to the intermediate compartment, where it mixed with the benzene from the drowning jets. The buoyancy mixture that was produced underflowed out the compartment with the aqueous phase (see Figure 5).
